EXECUTIVE SUMMARY

This Comprehensive Review (CR) examined the facts, circumstances and processes surrounding the recent Physiological Episodes (PEs) involving T-45 and FA-18 aircrew, including how these issues have been addressed. While conducting this examination the CR review included:

FA-18 OVERVIEW

T-45 OVERVIEW

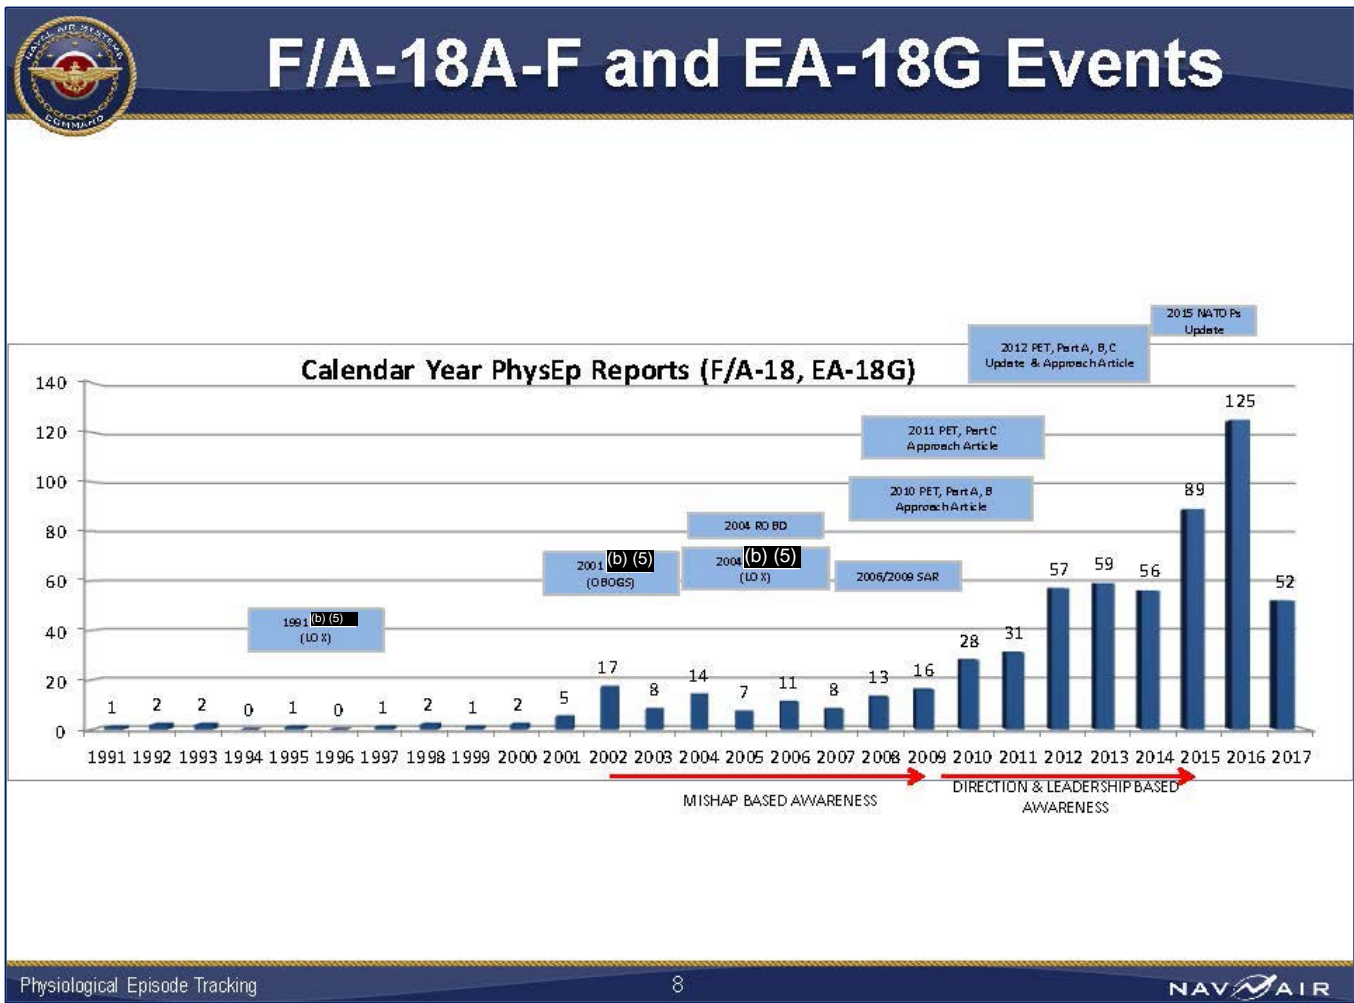
Figure 1 – FA-18 Physiological Episodes by Calendar Year

community: 31 in calendar year 2011; 57 in 2012; 89 in 2015; 114 in 2016; and 52 to date in 2017.¹³ Figure 1 below depicts reports of PEs in FA-18s by Calendar Year. The increased number of reports can likely be attributed, in part, to increased awareness throughout the Fleet regarding the PE phenomenon and the realization of the potentially dire consequences of a PE. Contributing to this increasing awareness were: joint NAVAIR – NAVSAFECEN presentations provided to FA-18 aircrew at Whidbey Island, Lemoore, Beaufort, Miramar, Atsugi and Fallon; NAVSAFECEN new reporting guidance in a naval message;¹⁴ an increased focus on PEs from the NAVSAFECEN during Squadron Safety Assessments; and continued engagement between the Physiological Episode Team (PET) and the Fleet.

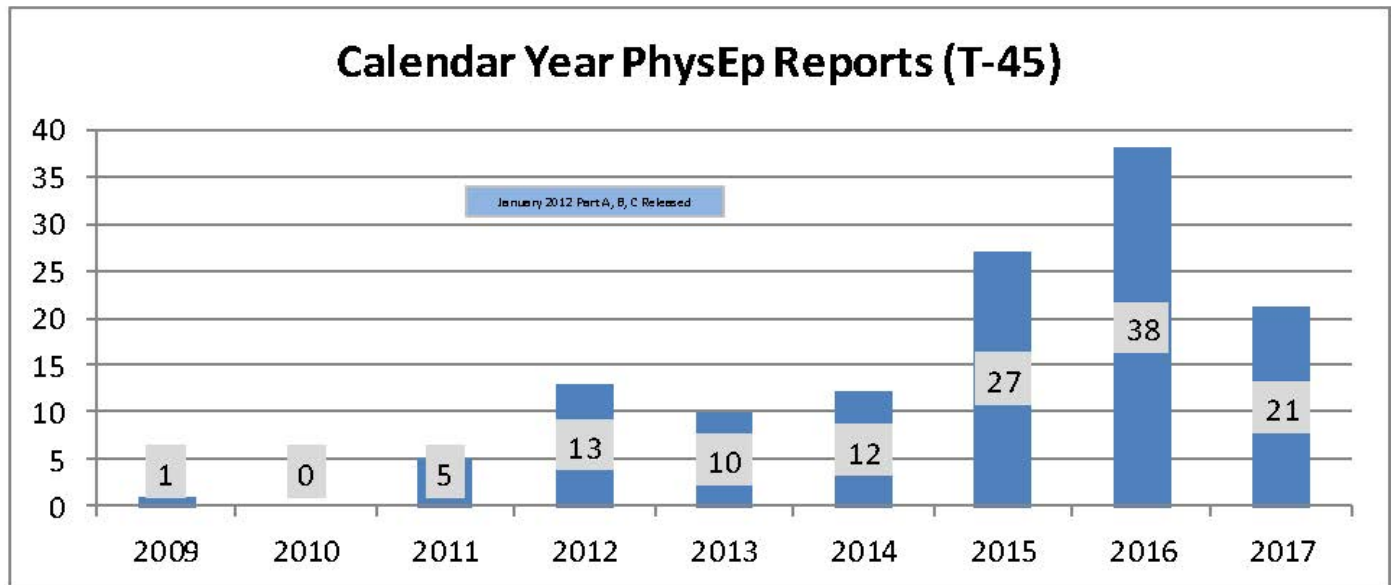
Figure 2 – T45 Physiological Episodes by Calendar Year

As previously discussed, the apparent PE increase in 2010 was likely more reflective of a change in aircrew awareness and reporting mechanisms than a sudden rise in PEs. Thus, comparison of pre- and post-2010 PE could lead to inappropriate conclusions. Since December 2011 there have been 112 T-45 PEs. Of these, 81 have been adjudicated by the Naval Aviation Enterprise (NAE). Analysis of the remaining 31 PEs is ongoing. Of the 81 adjudicated cases, 48 percent were determined to be aircraft system failures or human factors (i.e., fatigue, diet, procedural error); 28 percent were determined to be possible contamination; 24 percent were determined to be inconclusive.³⁰ Figure 2 below depicts reports of PEs in T-45s by Calendar Year. The aircraft system failures include two documented pressurization PEs since May 2016.
